LISTing Newsletter

Newsletter of the Long Island
Sinclair/Timex Users Group

January 1994 Issue
NEXT MEETING JAN 9, 1994

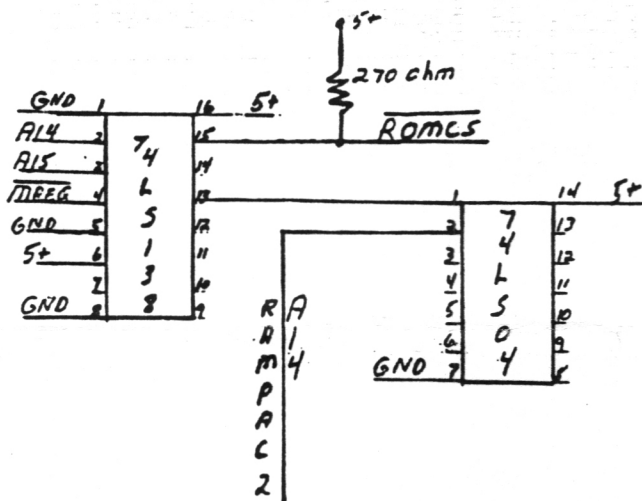
TS 1000 Memory Expansion - D. Dailey

THIS CIRCUIT WILL ENABLE A SECOND 16K TIMEX RAMPAC FOR 32K OF BASIC PROGRAM RAM. FIRST YOU NEED SOME WAY OF SPLITTING THE EDGE CONNECTOR SO THAT YOU HAVE TWO PLACES TWO PLUG ON THE RAMPAC'S AND A THIRD FOR A THROUGH CONNECTOR. RAMPAC ONE (16 TO 32K) WILL CONNECT AS NORMAL WITH NO INTERUPTION TO IT'S SIGNALS. RAMPAC TWO (32 TO 48K) WILL HAVE ALL IT'S NORMAL CONNECTION'S EXCEPT THE A14 LINE. THE OUTPUT FROM PIN TWO OF THE 74LS04 IS SUBSTITUTED FOR THE A14 LINE TO THE SECOND RAMPAC. AS WIRED ABOVE, THE 74LS138 WILL DECODE ADDRESSES IN 16K CHUNKS. THE OUTPUT FROM PIN 15 IS FOR ROM DECODING. IF YOU HAVE ANOTHER BOARD IN USE THAT DECODES THE ROM THIS CONNECTION IS NOT NECESSARY. THE 74LS04 IS A HEX INVERTER TO CHANGE THE ACTIVE LOW SIGNAL FROM THE 74LS138 TO ACTIVE HIGH. THE TIMEX RAMPAC'S DRAW ALOT OF CURRENT, SO PROVIDING A SEPERATE POWER SUPPLY (+5 & +9). THE MOD WORKS FINE ON A M4C T/S 1000.

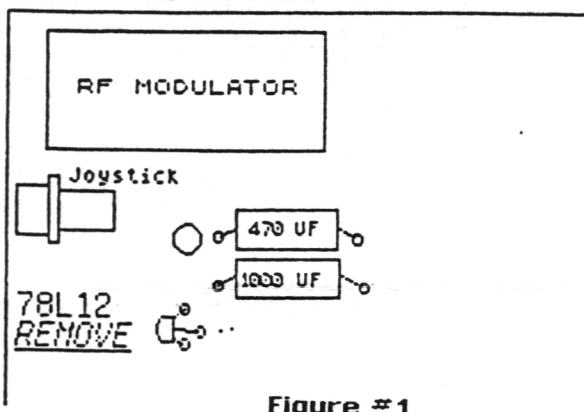
Figure #1

Using proper care, open your beloved 2068. Using Figure #1, find the 78L12 voltage regulator. It looks like an ordinary transistor (Only good for milliamps). Using great care, remove it. Make sure the holes are cleaned out. Now install the 78M12 (larger for more current) - Radio Shack part #276-1771, about \$1.50. Use Figure #2, noting that it is the BACK of the regulator that should be facing up. Now for the test! Move everything away from the circuit board, with the keyboard unattached, and power up.

INSIDE YOUR 2068

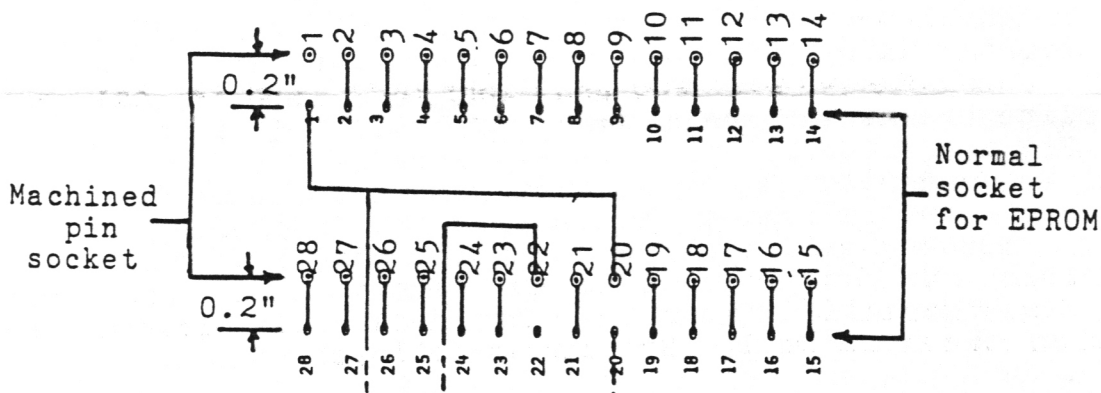
FIGURE: Partial back view of the daughter-board. The decoder IC, which on my board is a 74HCT00, is not shown.

protrude, and is fitted in the ROM socket on the QL mother-board. In order to install two sockets side-by-side one has to saw-off the stabilizing plastic bridges (two or three) which every socket has. The consequence of this is that when you want to install an EPROM in the normal socket, it flexes the socket rows sideways, so much so, that some times it is not possible to install the EPROM. This flexing causes the hairline cracks in the copper traces on the back of the daughter-board. Belatedly one discovers that in order to install the EPROM, one has to hold the two rows of the socket pins of the normal socket vertically by one hand, and then fit the EPROM in the socket. We discover this after we have already caused damage to probably more than one trace.

The second mechanism causing the cracks, is the way we normally install the flimsily made daughter-board, by pushing on the corners of the board. This method of installation causes too much pressure on the corner pins of the machined socket, and possible hairline cracks.

As such, the suggested procedure for installation is to first install the EPROM on the daughter-board, while holding the normal socket in a vertical position in one hand, thus avoiding the flexing of the pins of the normal socket. Second, install the daughter-board on the mother-board by pressing on the top of EPROM, thus causing the pressure to be equally distributed on all the pins of the machined socket.
